APPLICATION STORY

ŠKODA DEALERSHIP PROTECTS ITS PARKING LOT FOR NEW CARS WITH FLIR FC SERIES S THERMAL IMAGING CAMERAS

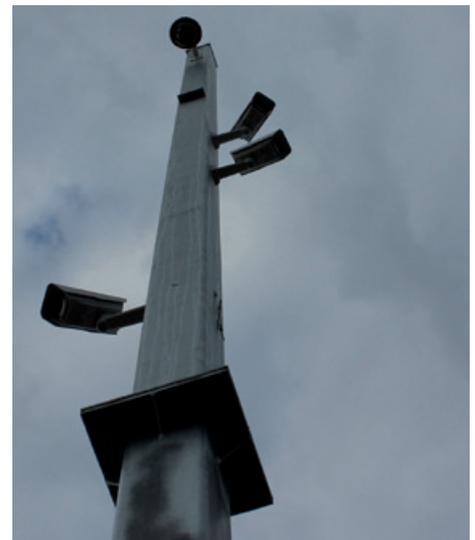
Three FC series S FLIR cameras monitor different areas from a central mast and, in the case of an alarm, they trigger a central high-speed dome camera to identify the perpetrator.

different directions. Tobias Vieth designed a 16-meter mast and had a structural engineer calculate it specifically for this purpose. "We decided to make it extra sturdy to avoid vibration and fluctuations in the camera image and thus allow for crystal clear presentation and accurate detection." A megapixel speed dome camera has been installed on the mast. As soon as the FLIR thermal imaging cameras detect suspicious activity, the speed dome automatically targets the location in question. This helps ensure clear identification of possible thieves.

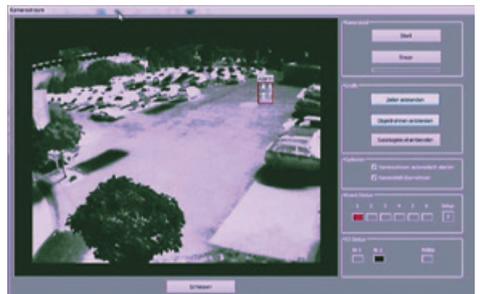
The video analysis method used here was specifically aligned with thermal imaging technology: If somebody gets into the secured area an alarm is being processed.
