APPLICATION STORY

New thermal fire detection system from FLIR promises a safer Krohnstiegtunnel

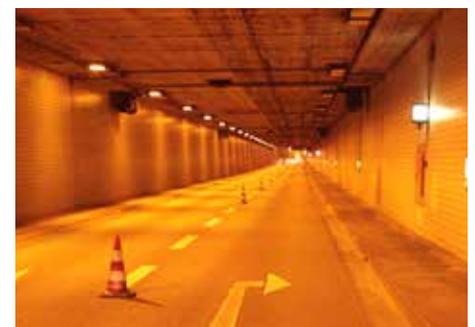
The FLIR ITS-Series AID is a thermal imaging camera with onboard video analytics for automatic incident detection and early fire detection.

The FLIR ITS-Series AID is a thermal imaging camera with onboard video analytics for automatic incident detection and early fire detection. The camera can measure the temperature of any object in its field of view, enabling it to detect fires at an early stage over the full detection range. The ITS-Series AID camera has a 640 x 512-pixel resolution, allowing the onboard video analytics to evaluate the source of the hotspot in greater depth. The result is fast, reliable fire detection with a low unwanted or false alarm rate.

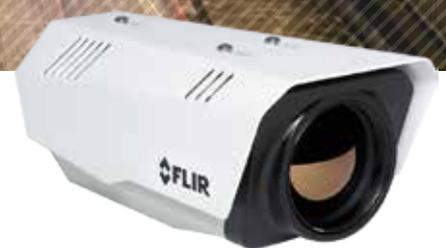
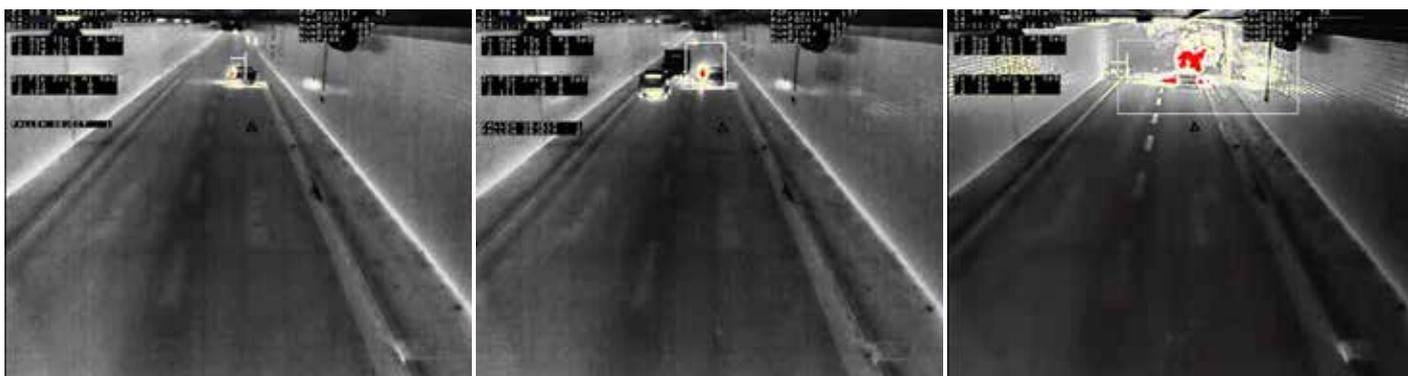
Thermal imaging cameras are capable of detecting fires within seconds of ignition, long before any traditional fire detection system can trigger an alarm.

Thermal imaging cameras outperform other fire detection technologies. They detect the heat energy given off by everything in their field of view. Unlike other fire detection technologies, no contact is required with flames or heated gases, nor is any smoke propagation needed for the camera to pick up an initiating incident or fire generated by a vehicle malfunction. As a result, a thermal camera with appropriate fire detection analytics can detect fire within seconds of ignition, long before any traditional fire detection system can trigger an alarm.
