## APPLICATION STORY

### Washington PUD Relies on Thermal Imaging to Keep the Lights on for Residents

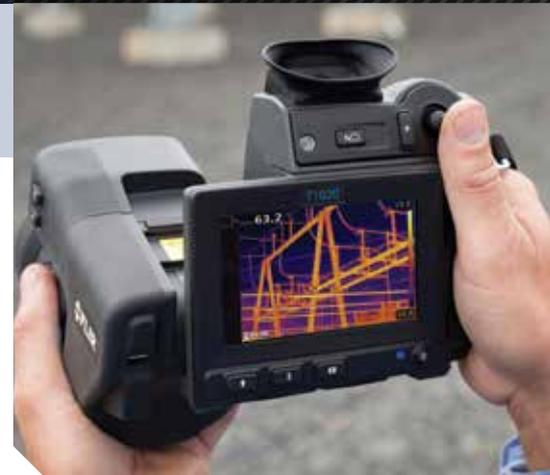
FLIR T-Series thermal imaging cameras provide the resolution and range needed to accurately measure electrical hot spots, even from a distance.

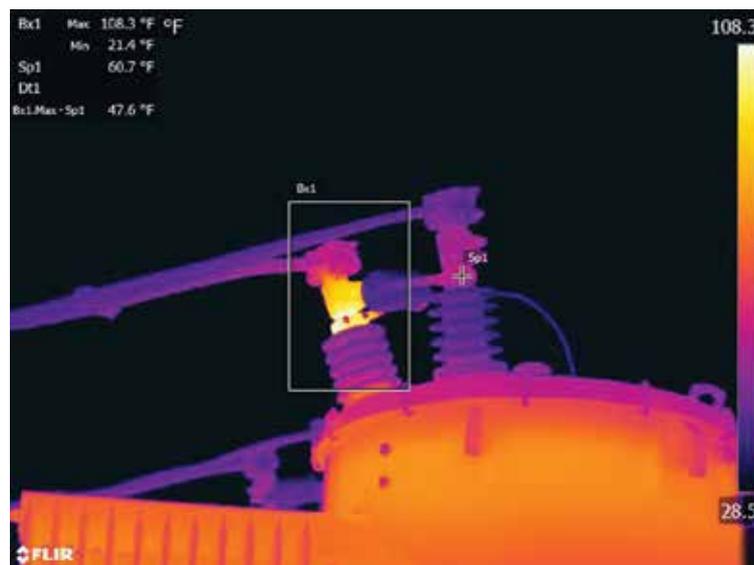
The bushing atop a regulator on the C-phase circuit at PUD 3's Mountain View substation was failing. Without timely repairs, this failed connection would have caused \$40,000 in damage and cut service to about 3,000 customers.

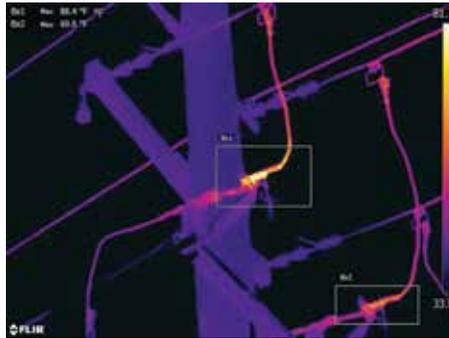
Engineers discovered four hot spots on this gang-operated switch. Two of the phases had failing hot taps and jumpers, and two of the three switches were failing. A failure on this structure would have affected nearly 1,500 customers.

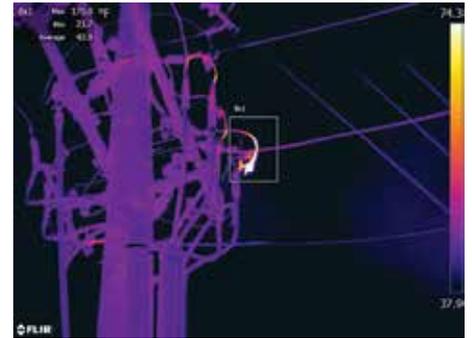
A failing hot tap on the connection between an overhead to underground power line on a riser structure at PUD 3’s Union River Substation needed to be repaired quickly to avoid an outage that would have affected about 1,000 customers.

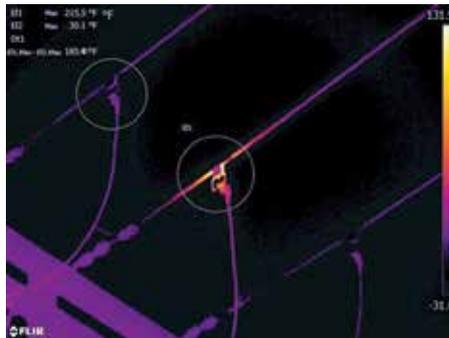
The center-phase hot tap is showing imminent failure. This hot line-clamp, or bail, connects two circuits together. A poor connection on the line clamp is causing heating on the primary line. Had it failed, 2,250 customers would have lost service.

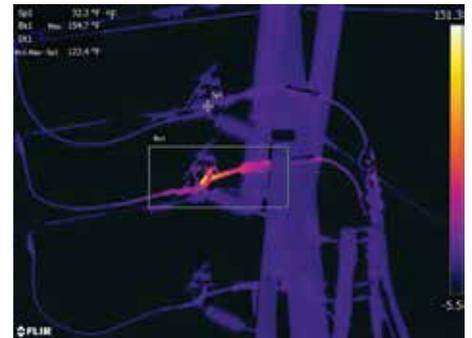
The center phase of this gang-operated switch at PUD 3’s Pioneer substation was failing. If not repaired the switch would have burned up, cutting power to about 1,600 customers and posing a safety hazard to linemen who had to operate it.

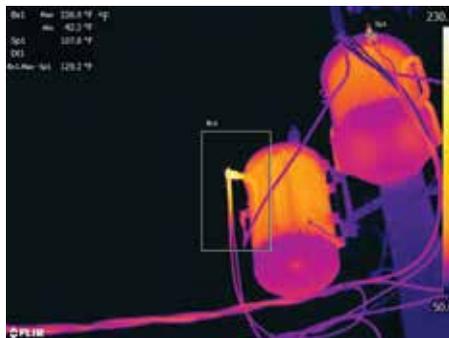
This image of a three-phase transformer bank at a local cedar mill shows a bad secondary bushing on one of the transformers. If this had not been discovered, the result would have been a costly shut down for the mill – thousands of dollars per hour of lost productivity.

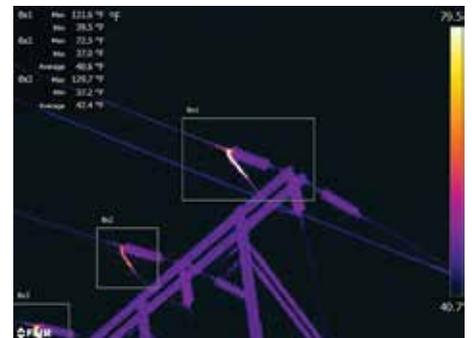
Thermal imaging helped PUD 3 locate this failing dead-end bell on 115,000 V power lines before it caused a lengthy outage for nearly 2,000 customers.
