APPLICATION STORY

MOBILE THERMOGRAPHIC MONITORING OF BELT CONVEYORS HELPS AVOID FIRES

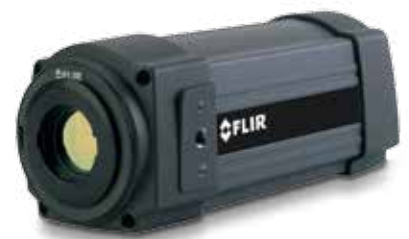
The FLIR A310 thermal imaging camera

permanently installed thermal imaging camera from the FLIR A series. The FLIR A310 was mounted on the bed of an SUV and pointed in about a 45-degree angle to the direction of travel. Among other things, a special housing unit was required to securely mount the FLIR A310. The thermographic camera system can operate without any cable connection, because it includes a battery power supply and a wireless communication unit.

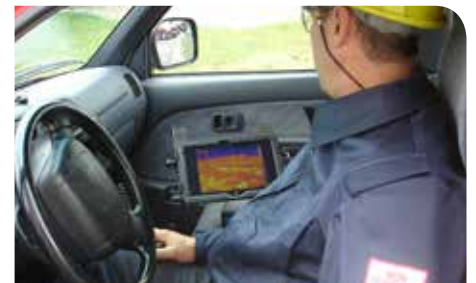
Monitoring with the tablet PC

Klaus Flocke recommended a wide-angle lens to cover as much of the conveyor belts as possible while passing by. The A310 transmits the camera image via Wi-Fi to a tablet PC installed in the driver's cab. If a preset alarm temperature is detected, this tablet PC emits an acoustic warning signal. Only then the driver (who otherwise focusses entirely on driving about 20 km/h at a distance of 2-15 meters away from the conveyor belts) checks the image on the monitor and locates the overheated section of rollers on the conveyor belts.

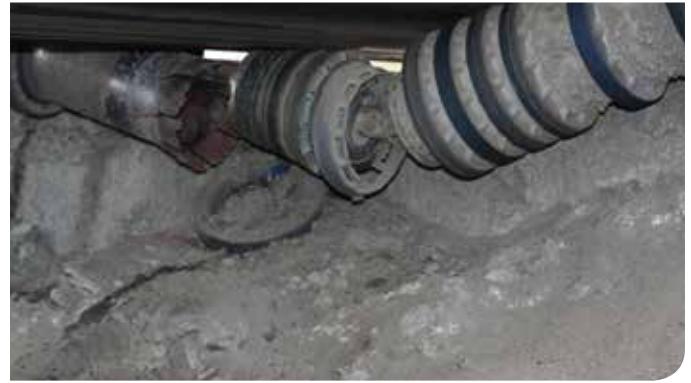
Defective lower support roller of a belt conveyor

At its strip mines, MIBRAG operates approximately 70 km of belt conveyors, which include steel rollers and idlers with rubber or polyurethane support rings. Wear on the bearings can cause overheating, which can ignite the lubricants and support rings of the lower rollers. Even the upper steel rollers can heat up to the point that the steel starts to glow. Especially when a belt conveyor is at a standstill, a large fire hazard can arise after just 10 to 15 minutes.

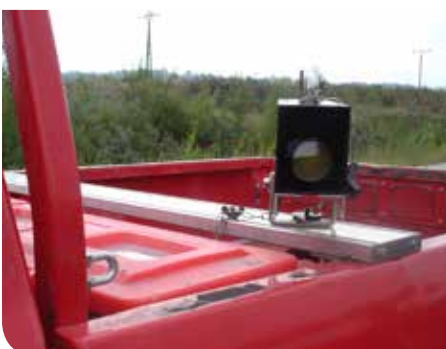
The FLIR A310 was mounted on the pick-up in a special protective housing
