APPLICATION STORY

GUBBA COLD STORAGE USES THERMAL IMAGING TO GUARANTEE BEST COLD STORAGE CONDITIONS.

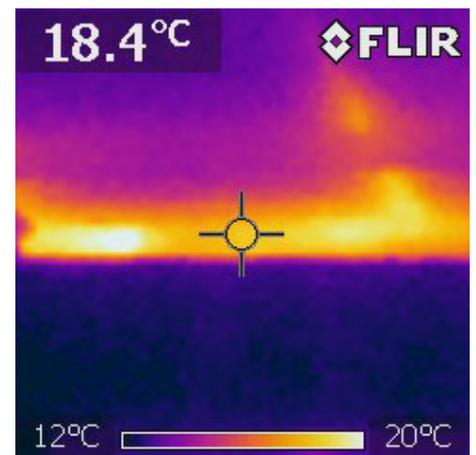
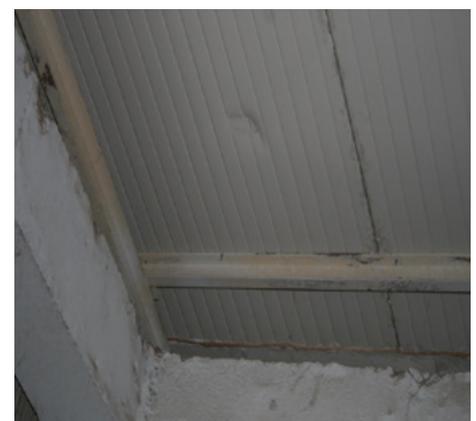
Leaks in the insulation material covering the cold storage unit can be a threat to the temperature uniformity inside the unit.

To preserve the temperature in the cold storage units, the quality of insulation is of course of utmost importance. Leaks in the insulation material covering the cold storage unit can be a threat to the temperature uniformity inside the unit. However, insulation leaks used to be discovered in a rather random fashion and repaired on the fly. What's more, insulation leaks can also allow moisture to enter the unit, which can also disturb the required relative humidity. The moisture that enters the building will condense and freeze. Eventually, the build-up of ice can also affect the insulation properties of the cold store wall and weaken the structure of the wall or building.

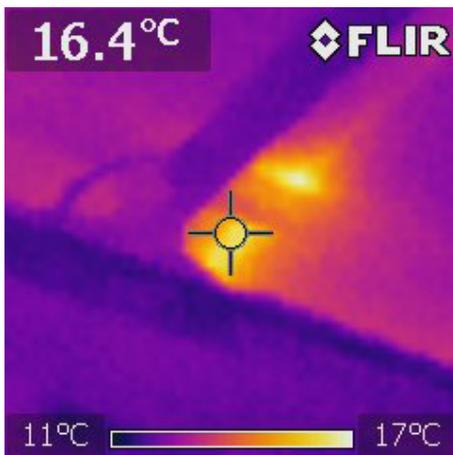
Small insulation leakages can easily be detected before they escalate into something worse.

At Gubba Cold Storage, Gubba Prashant is now frequently using a FLIR i3 point-and-shoot camera to monitor the cold storage units and to detect possible leakages. One of the many advantages of this new approach is that inspections can now be scheduled in advance and on a regular basis. Small leakages can easily be detected before it escalates into something worse. And more importantly, by blocking these leakages in time, uniformity in temperature and relative humidity is maintained in the unit. This helps Gubba Cold Storage to save its customers' stocks from perishing.

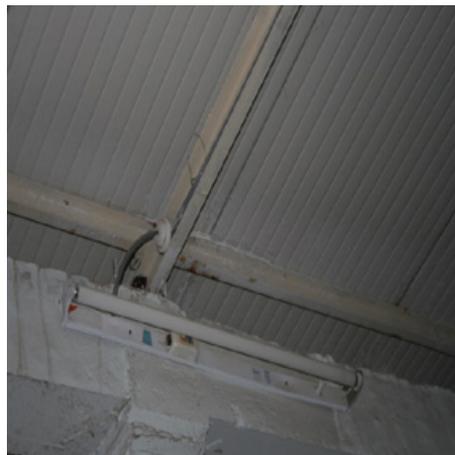
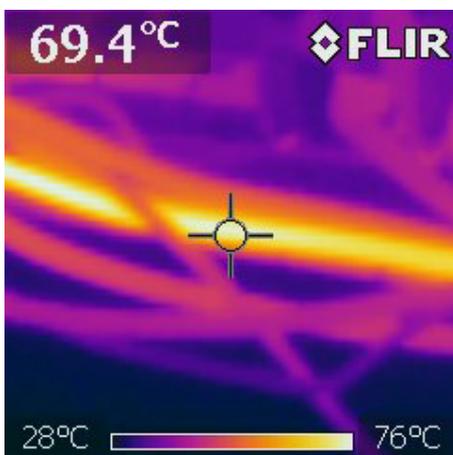
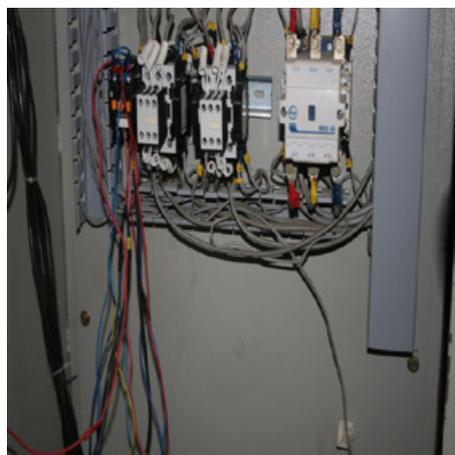
Gubba Group uses the FLIR i3 camera extensively for safety checks in electrical panels and chiller rooms across its various cold storage buildings.

Aside from detecting heat and energy loss in cold unit storage structures, FLIR's thermal imaging camera has proved to be an accurate & effective tool in Gubba Cold Storage's facilities predictive maintenance programs. In electrical installations, hot spots in the thermal image usually point to emerging problems. With the FLIR i3 camera, Gubba Prashant's team can now scan electrical cabinets and components and survey multiple wires and connections to get an instant picture of potential trouble.

"We use the FLIR i3 camera extensively for safety checks in electrical panels and chiller rooms across our various cold storage buildings," says Gubba Prashant. "When the thermal imaging camera clearly shows you an electrical cable that is much hotter than its environment, you know you have to intervene. This is how we can prevent bigger problems from happening."
