# APPLICATION STORY

## "THE INFRARED RESOLUTION IS SIMPLY TREMENDOUS."

The engineering firm Adler in Herten in the German Ruhr area is using the top-of-the-range FLIR T1020 handheld thermal imaging cameras for maintenance applications.

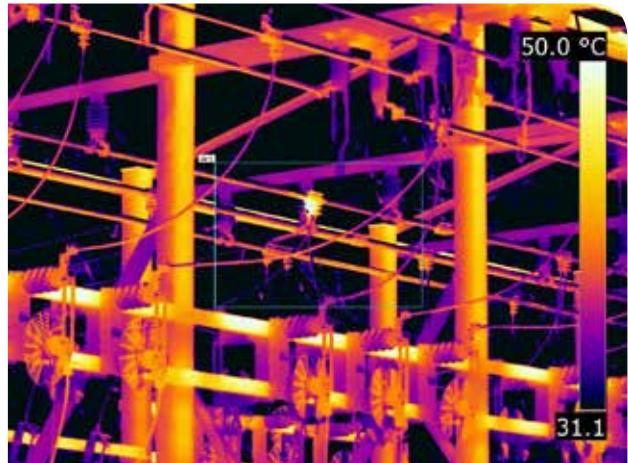
Thermography of high-voltage components always requires a relatively large safety distance. The UltraMax feature can be particularly helpful in this regard by providing good resolution and accuracy even from a distance.

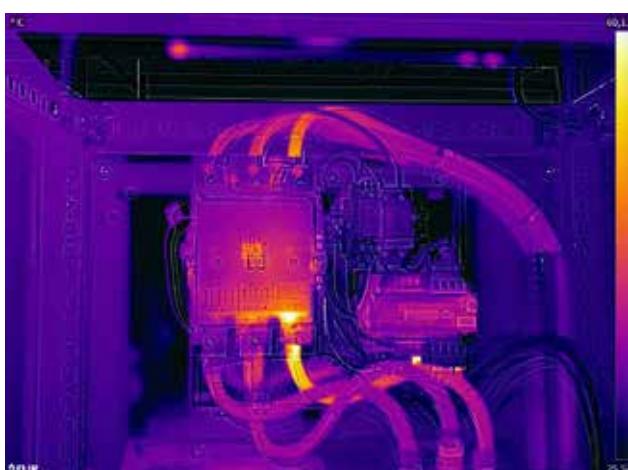
Contactor with pronounced abnormality of the right phase on the lower terminal connection. The possible cause could be increased resistance at the terminal connection, an internal connection or the contactor. The labels are also easily recognizable here thanks to the MSX feature.

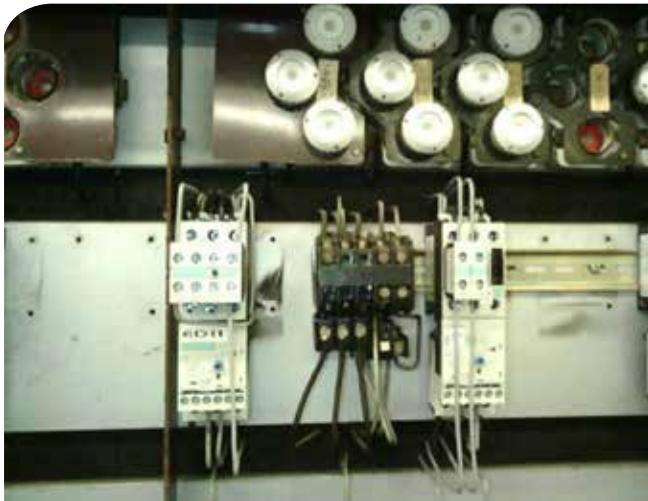
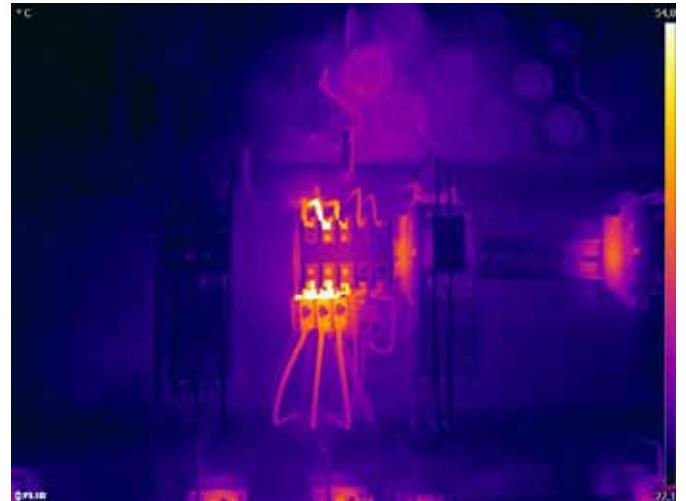
The middle phase of this motor protection switch looks abnormal. This could indicate increased resistance at the terminal connection.

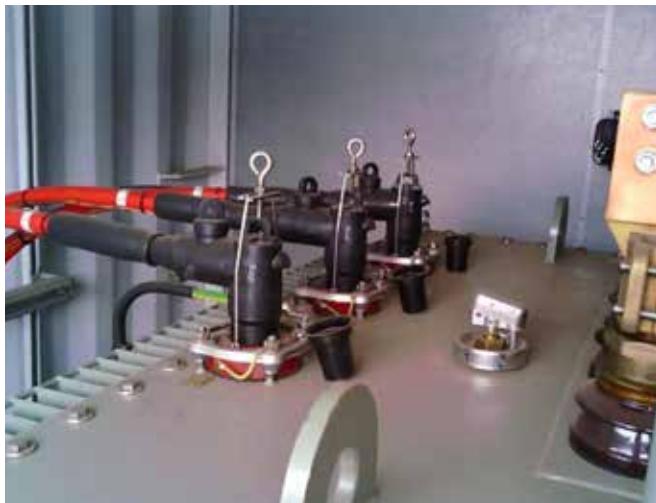
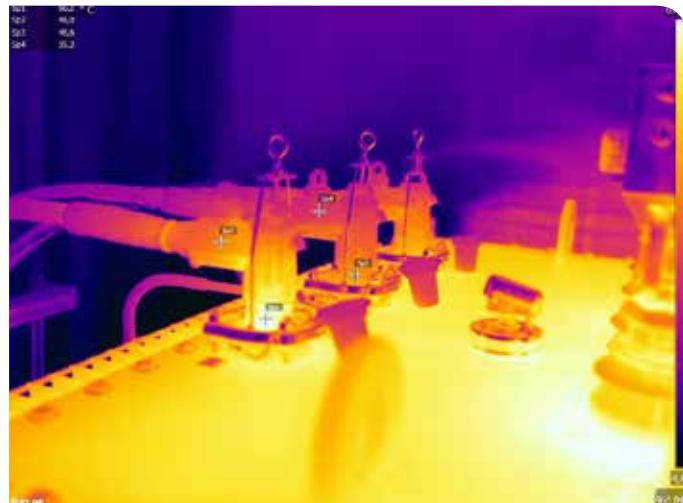
Alternator with abnormality on the primary front plug connector. A bent pin on the angle plug connector is found to be the cause.

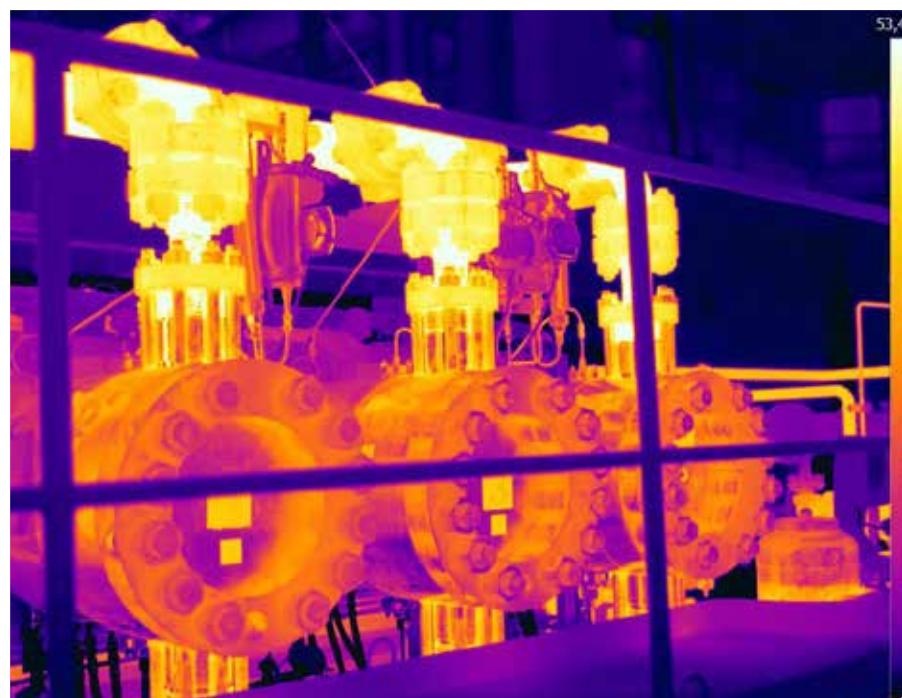
High pressure compressor heads in a chemical plant (within the area at risk of explosion).

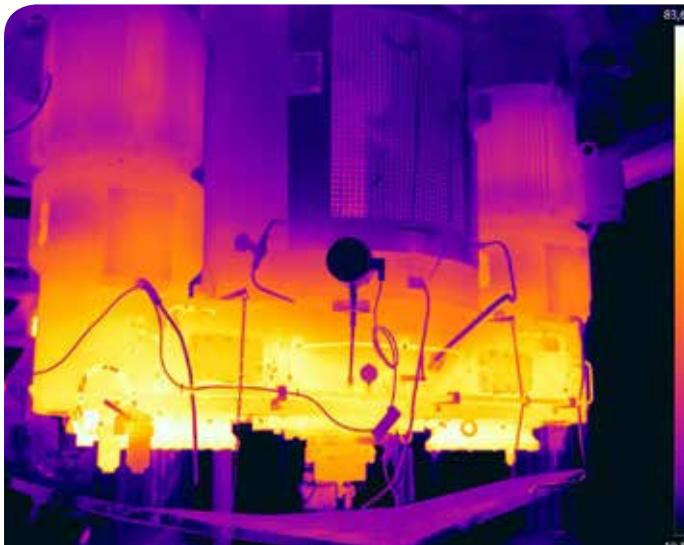
Agitator drives below a mixing tank in an area at risk of explosion in a chemical operation.

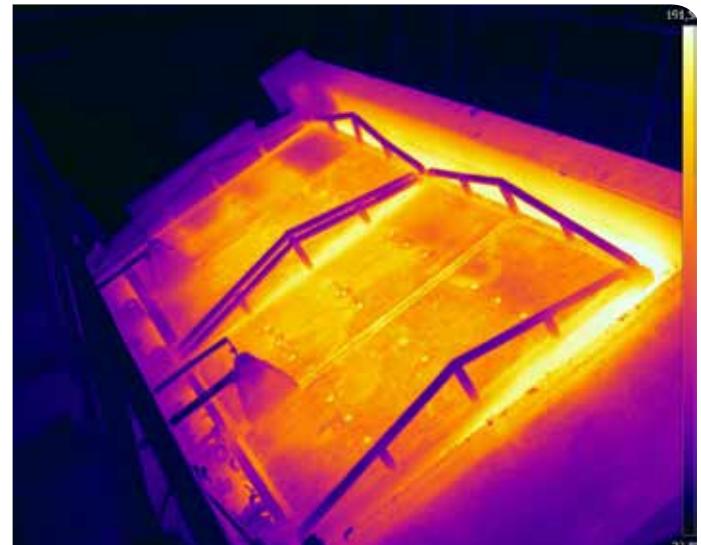
Regular thermal images of a melting furnace allow for determining the condition of the lining.

Industrial furnaces consist of a furnace shell which is protected by a fire-resistant inner lining against the extreme temperatures of the molten metal. Of course this lining

is exposed to normal aging processes: It is exposed to wear in operation and is eventually damaged to the extent that it requires replacing. The time between two linings is called the "travel time", and the longer the journey, the more economic the operation can be. However, a furnace with a defective lining could also have disastrous consequences. The molten metal would destroy the shell and, in addition to high costs, this could even cause injury in the worst case. Using a thermal imaging camera, it is possible to determine the condition of the lining from outside the furnace even during operation. Regular thermography
