APPLICATION STORY

BP CHEMICALS ENHANCES SITE SAFETY WITH FLIR INFRARED

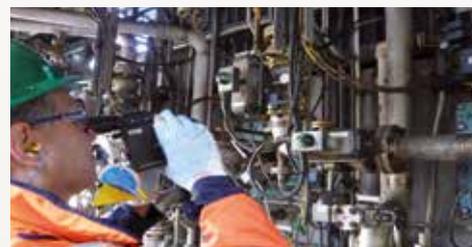
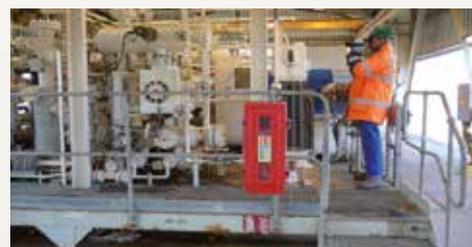
Unlike other gases at Saltend CO doesn't have the advantage of odour and therefore unless the emission exceeds the alarm setting of a personal monitor or a fixed detector, a leak will remain undetected. The first small escapes that the FLIR GasFindIR CO camera found were from an infed pipe and a heat exchanger flange, both part of an electrically driven compressor. From a gantry in an adjoining covered section of the plant, the camera was then used to inspect a series of steam driven compressors. Two further CO leaks were found. In high sensitivity mode both were clearly visible as plumes of gas. "These were great

In both pictures CO leaks were found with the GasFindIR CO
