FLIR thermal imaging cameras help prevent power failures at utilities

'Detecting maintenance issues before failures occur is crucial to E.ON Bayern'

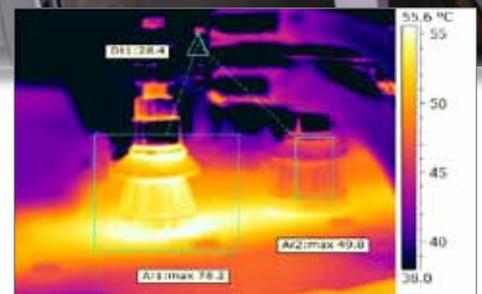
With temperatures approaching 80° C this transformer requires further inspection.

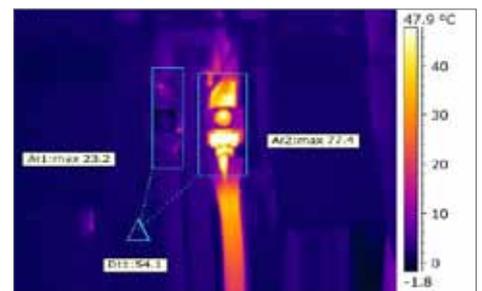
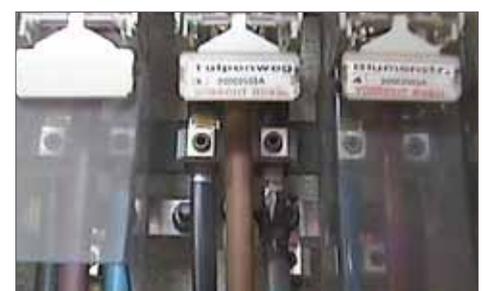
This connector has become resistive due to loosening and corrosion. This can be easily remedied by opening, cleaning and reassembling the connector.

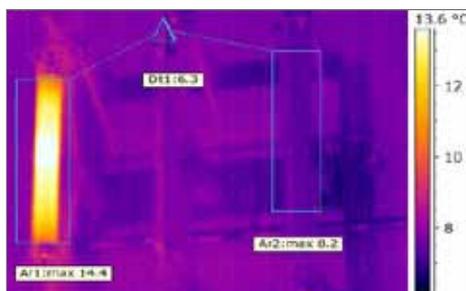
The overheating high voltage fuse should be replaced and the contacts should be cleaned.

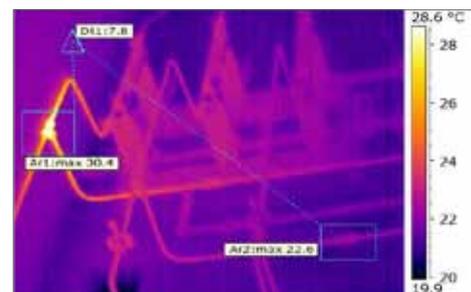
The T-connector that shows up as a hot spot is overheating due to increased resistance. This can probably be solved by cleaning the connector.

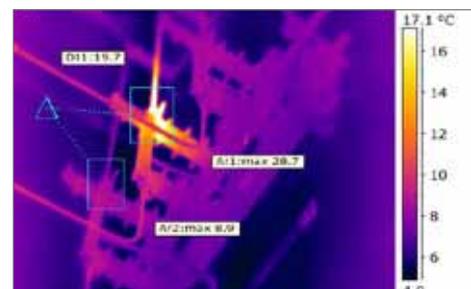
This wait switch requires further inspection and might have to be replaced.
