FLIR thermal imaging camera helps find water leakage at Italian swimming pool

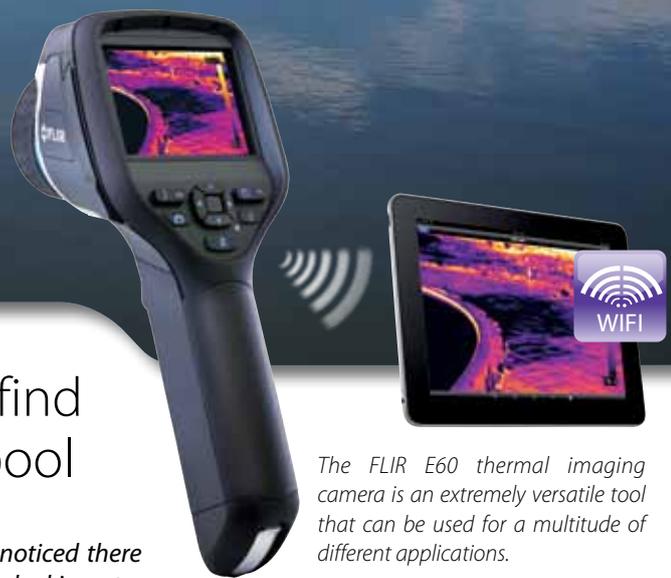
The FLIR E60 thermal imaging camera is an extremely versatile tool that can be used for a multitude of different applications.

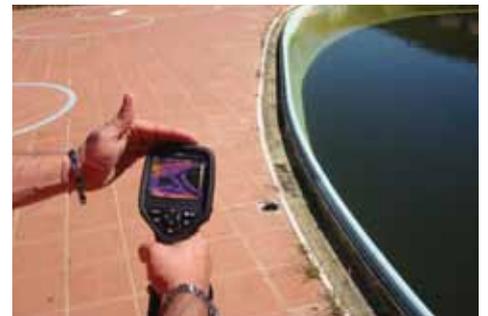
The FLIR E60 thermal imaging camera clearly localized the water leaks.

up the pipes. "This showed that some of the pipework in those locations was cracked or broken. This validated the findings in the thermographic survey, showing very clearly that this method had led to an accurate localization of the problems."

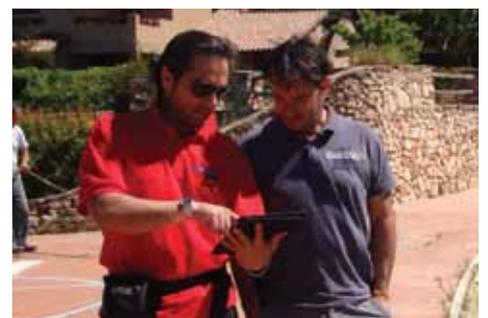
Contino shares the results of his survey with the apartment administrator on site thanks to the WiFi connection with his iPad.

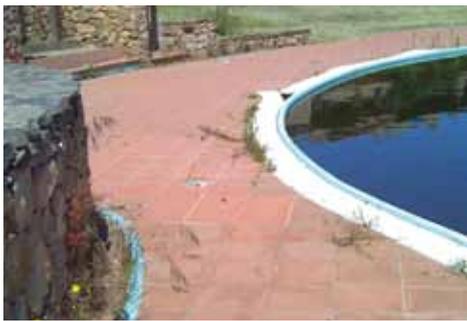
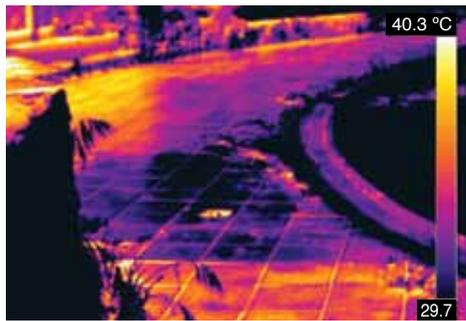
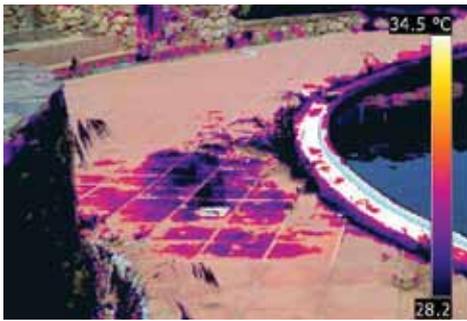
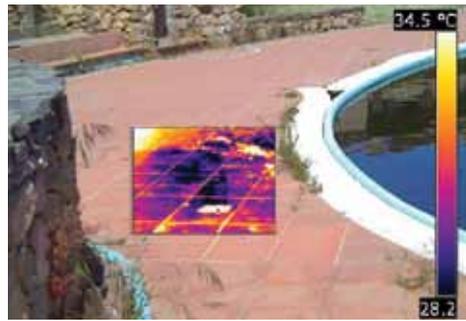
These images show how the visual image and thermal image can be combined into a Thermal Fusion image or by using the Picture-in-Picture feature.

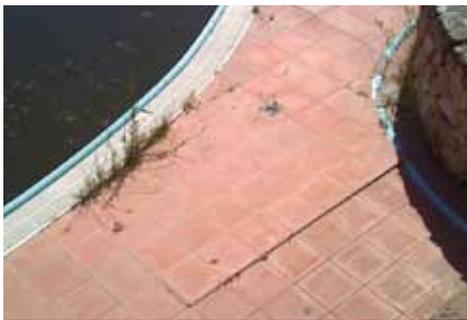
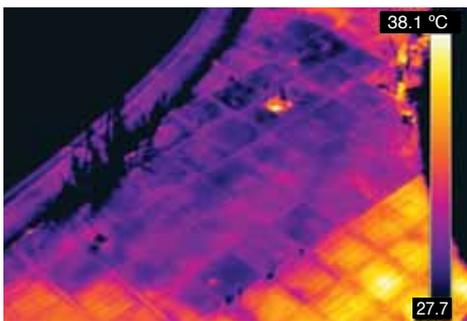
An initial survey did not show enough decisive signs of leakage, so Contino took it one step further. He plugged the nozzle of the pool cleaning system, thus pressurizing the water in the pipes. “The pavement was warmed up by the sun, so at the location of the leakage we suspected that the water leakage would cool down the pavement. So after waiting for two hours we performed a second survey and looked at the differences between the two. And just like we thought there were two suspicious areas in the second survey that appeared cooler in the thermal images. So you could say we used the sun as an infrared illuminator.”

Visual and thermal image of one of the two suspected areas.

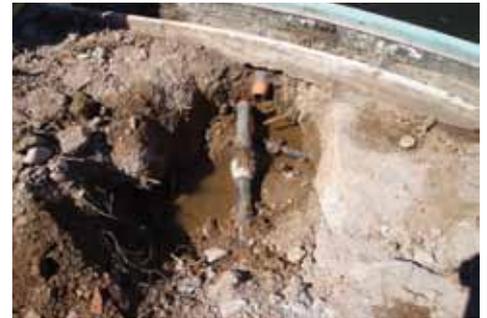
The repair workers were directed to open up the pavement where leaks were inspected, to find broken or cracked pipework, validating the results from the thermographic survey.

Due to the precise localization and immediate communication of the problem the repairs were swift and the pool was repaired before the guests arrived. "The use of a thermographic survey with my FLIR E60 thermal imaging camera has saved time, effort and money."
