Thermal imaging cameras help preserve Italy's cultural heritage

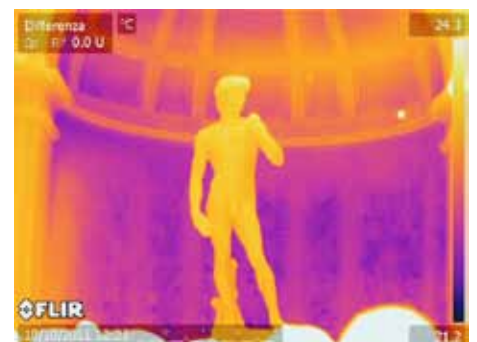
This thermal image reveals the underlying texture of the walls and pillars of the apse in which Michelangelo's David is placed.

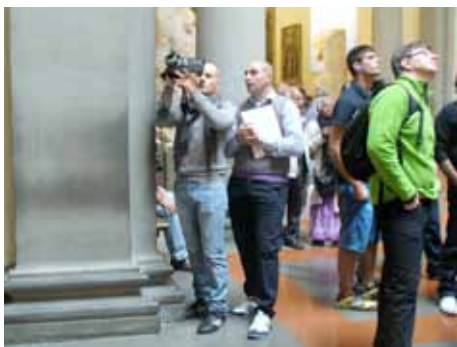
IR HotSpot thermography experts Rosario Piergianni and Vito Basile demonstrate the use of the FLIR SC660 thermal imaging camera.

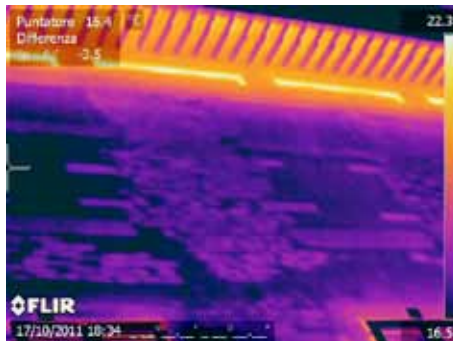
Evaluation of the infill masonry between the Accademia Gallery and the cloister of the Academy of Fine Arts.

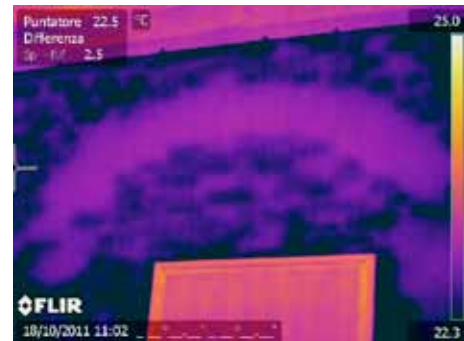
This thermal image shows that below the surface this wall along the nave of the Accademia Gallery contains arches for better weight distribution.

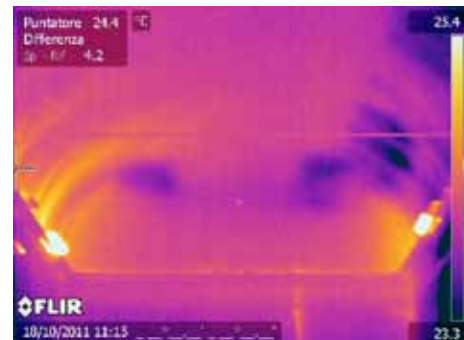
In this thermal image the dark spots indicate moisture ingress in the vaults of the Museum of the Academy.
