Inspection of climate control ceilings using thermal imaging cameras

Climate ceilings

Inspection with a thermal imaging camera

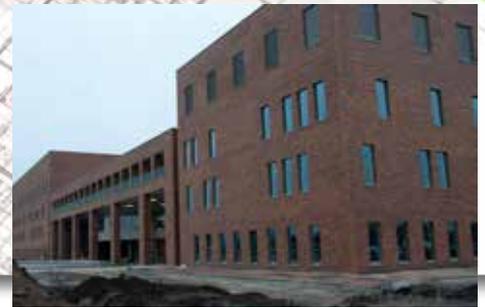
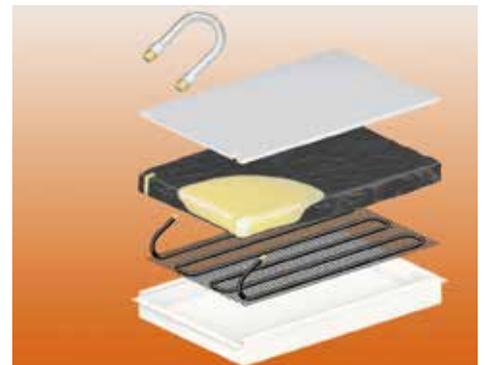
The MeandRo system used consists of perforated sheet steel ceiling panels in a sandwich construction, factory-equipped with a MeandRo element.

The climate control ceiling installed in Bernhoven Hospital is the MeandRo system developed by Inteco. The MeandRo system is a radiant ceiling for cooling and heating, using the passage of both hot and cold water and consists of perforated sheet steel ceiling panels in a sandwich construction, factory-equipped with a MeandRo element. This element is comprised of meandering 8 x 0.5 mm copper tubing soldered across its entire length to a heat conductor with a very open structure and the inner dimensions of the panel and it is applicable in any aesthetic

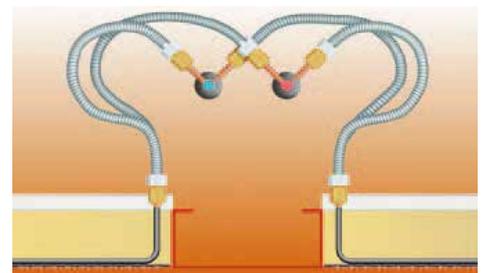
Simple mounting system using quick links for the passage of hot and cold water.

design. The MeandRo elements are attached to each other using quick links, and that is precisely where errors can occur during installation. However, an expert, post-delivery inspection allows for rapid, simple correction of these errors.

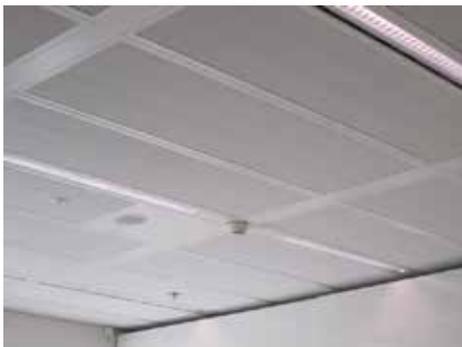
The passage of hot water can be clearly seen in the thermal image (right).

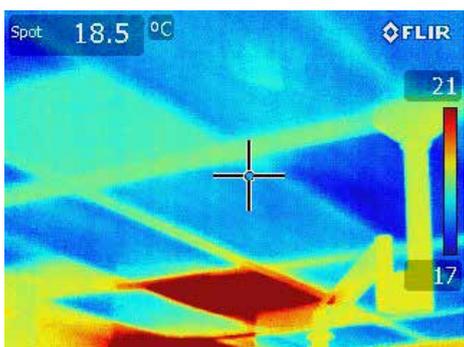
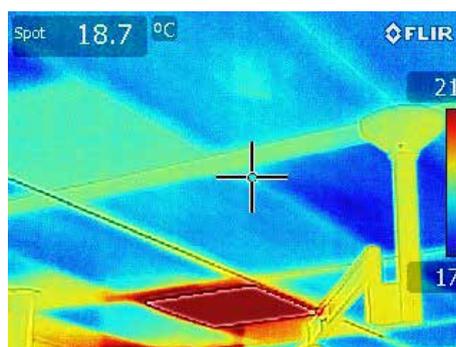
In the image with MSX to the right, the texture of the climate control ceiling now being cooled is quite visible.

This functionality ensures better texture in a thermal image so that an extremely detailed thermal image is provided. Thanks to this new functionality, more deviations can be detected, analyses can be performed more accurately and conclusions can be drawn immediately.

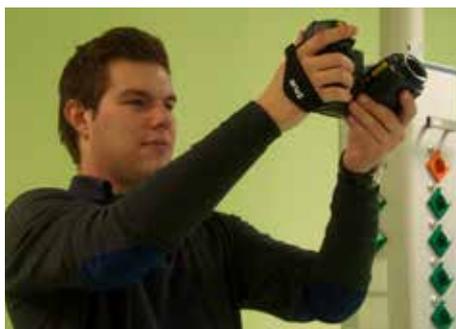
De FLIR T440bx series is equipped with a tiltable optical unit that allows for picture-taking from every desired angle with a comfortable work posture.

The extremely ergonomic FLIR T440bx thermal imaging camera was developed for users who demand high performance at an affordable price. The FLIR T400bx series combines perfect ergonomics with high-quality images at 320 x 240 pixels. De FLIR T400bx series is equipped with a tiltable optical unit that allows for picture-taking from every desired angle with a comfortable work posture. For the building trades in particular, the FLIR T440bx has a built-in compass. So the inspector can note the direction he's viewing and the direction to which a wall is oriented. This can be important when conducting building inspections. The camera's direction of view is added automatically to each image.
