Integral UK helps its customers save costs and reduce downtime of chillers.

FLIR GF304 camera ideal solution for detection of refrigerant gas leaks

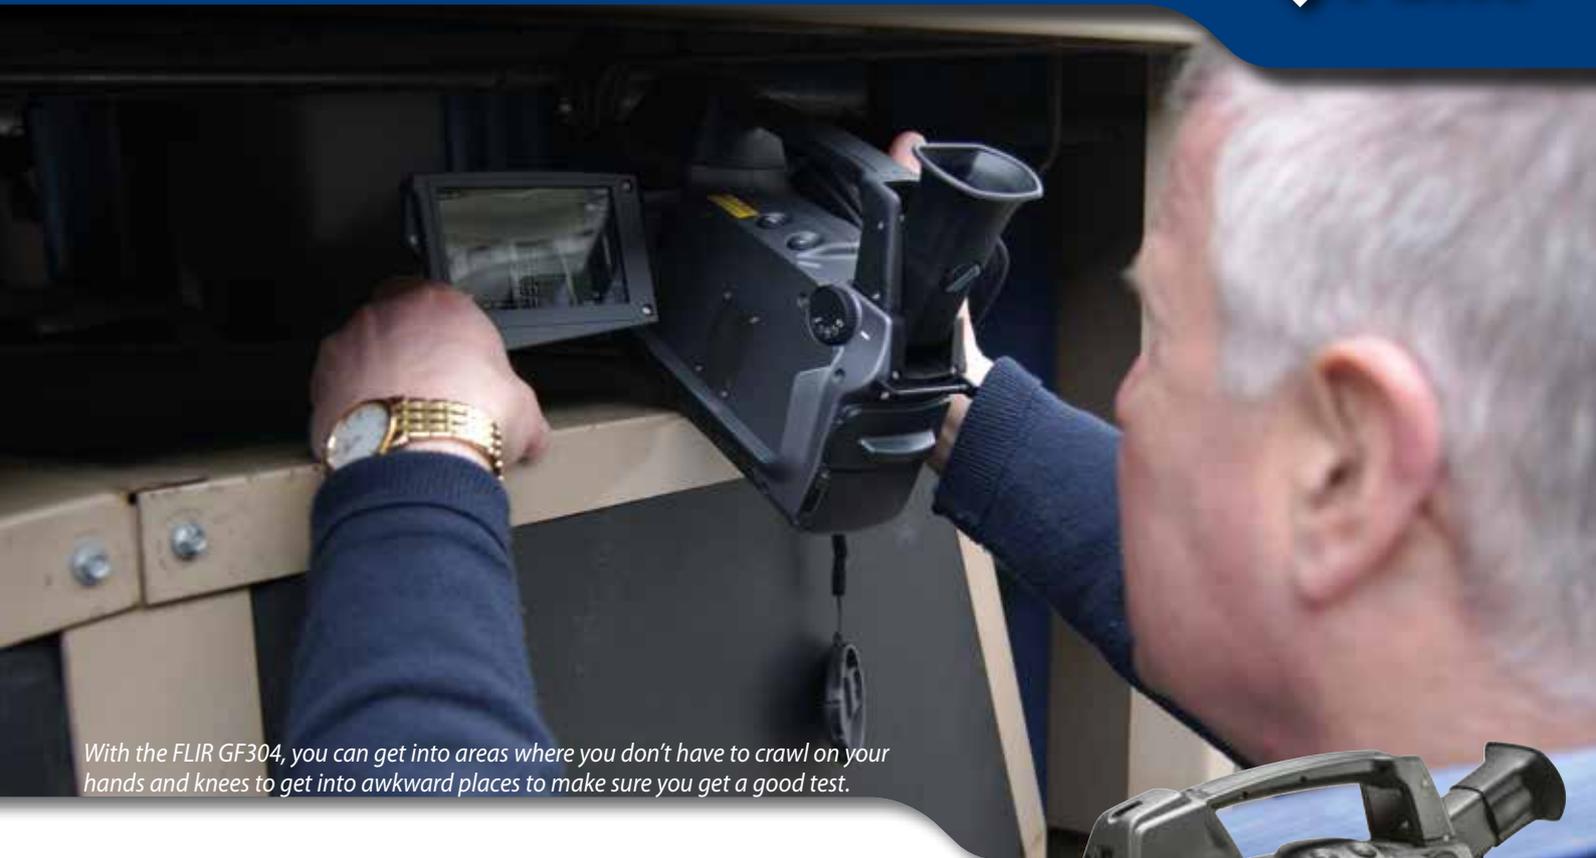
With the FLIR GF304, you can get into areas where you don't have to crawl on your hands and knees to get into awkward places to make sure you get a good test.

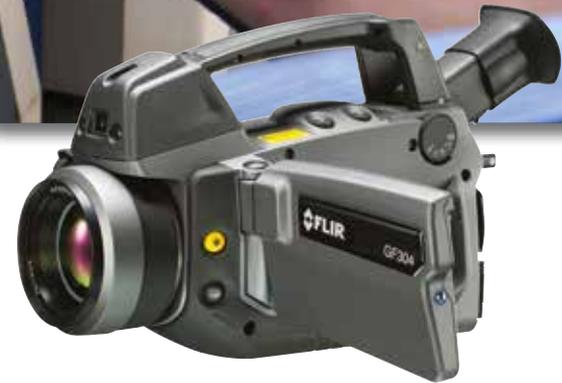
The GF304 gas imaging camera was especially developed for the detection of refrigerant gases without the need to shut down the operation.

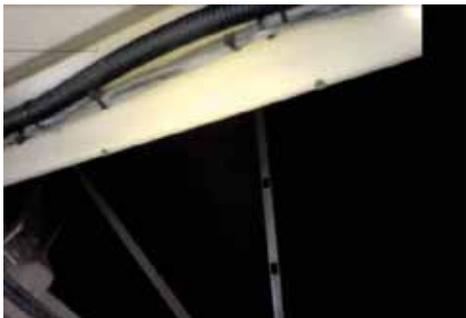
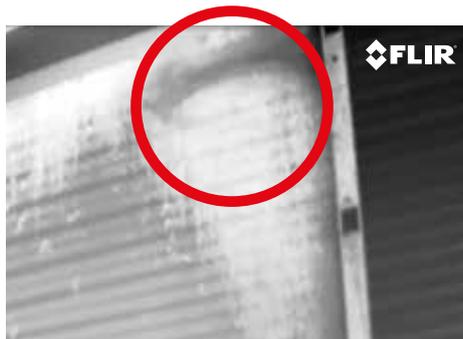
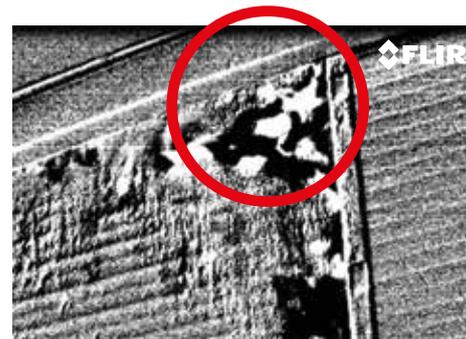
A refrigerant gas leak in visual video, thermal video and thermal video in High Sensitivity Mode (HSM)

Integral provided one example where, after a maintenance visit, their subcontractor chiller company told them they had a suspected refrigeration leak. Integral decided to take the FLIR GF304 camera to see if they could locate a leak. The survey was already carried out the next day and quickly and efficiently confirmed there was no leak. This replaced traditional methods where the chiller had to be degased and checked for leaks visually and then recharged – a procedure which could take a week or more. This operation kept the chiller fully operational and Integral was able to avoid the pitfalls of extended downtime. Thanks to these time gains, this saved the client much money, in this case £1200.

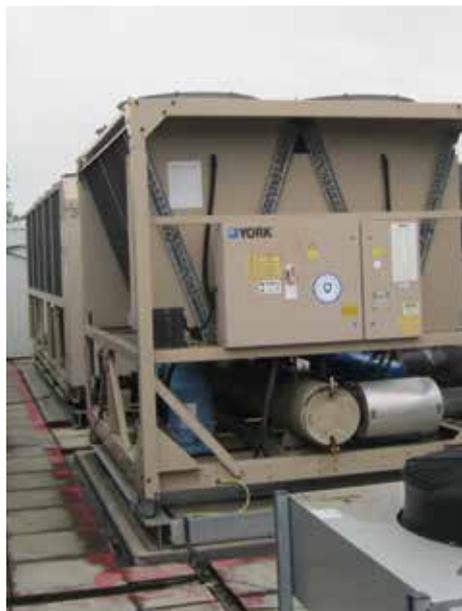
Because of wear or damage, chillers can present leaks, through which refrigerant gases can escape.
