Thermal imaging allows for accurate and time-saving inspections of electrical cabinets inside aircraft cockpits.

Thermal imaging for cockpit inspections

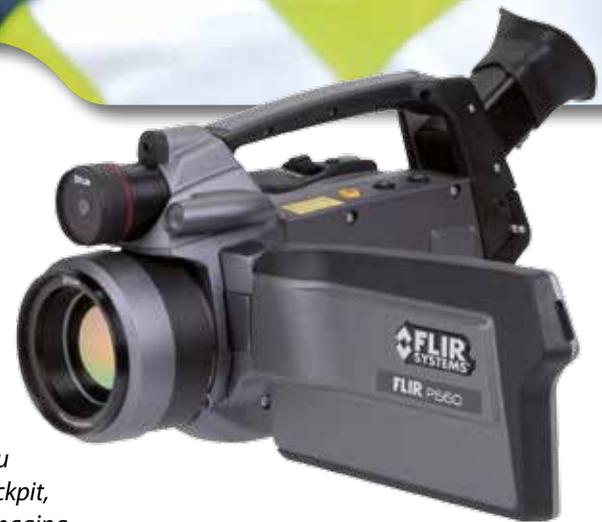
The high-res P640 thermal and visual camera is a smart choice for thermal imaging surveys.

Thermografisch & Adviesbureau Uden BV is using the FLIR P640 thermal imaging camera, a high-resolution thermal and visual camera that has a host of advanced features, which makes it a smart choice for thermal imaging surveys.

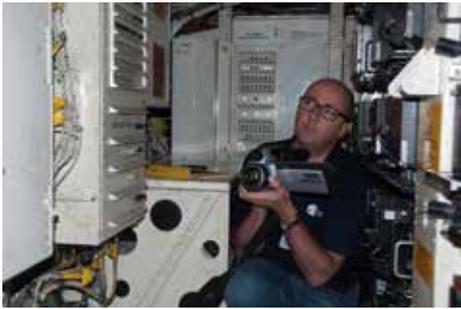
The FLIR P640 allows us to view the smallest electrical parts and the smallest temperature differences.

"The camera provides us with a very high resolution, which enables us to view the smallest electrical parts as well as the smallest temperature differences," comments Mr. Grispen. "An additional benefit of the FLIR P640's large color LCD is that you can simultaneously share your images with your customer or your colleagues. For us, this is a feature that cannot be underestimated, because it allows us to reassure our customers and show them that we do a good job."

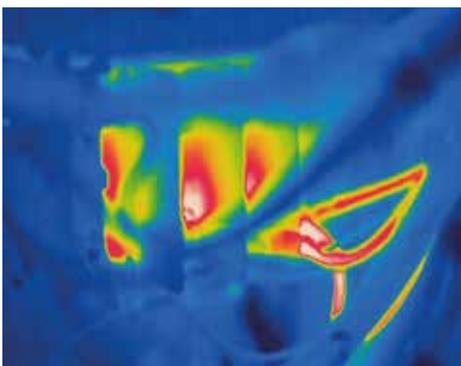
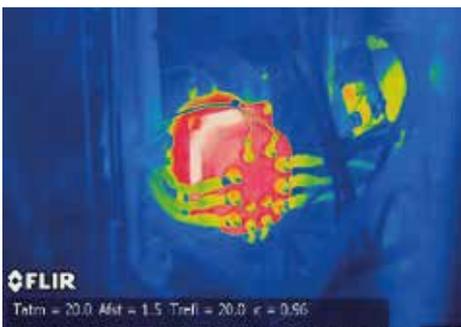
The FLIR thermal imaging camera was able to detect a temperature increase in the electrical wiring and components.

"Faulty resistors heat up, and that's exactly the reason why thermal imaging technology can easily detect such defects, even very small problems in an early phase," comments Mr. Grispen. "In the case of Star Air, this technology proved to be a perfect fit for preventive maintenance and electrical inspections inside the cockpit in general. Especially with older aircraft, which are subject to wear, it is critical to inspect connections and fittings on a regular basis. With thermal imaging cameras from FLIR, we can get this job done in a fast, accurate and cost-effective way."

Cockpit inspections with thermal imaging technology are very accurate and time-saving. The main advantage of thermal imaging is that you can locate electrical problems very quickly and accurately. With thermal imaging you are able to immediately see which component is causing the problem.

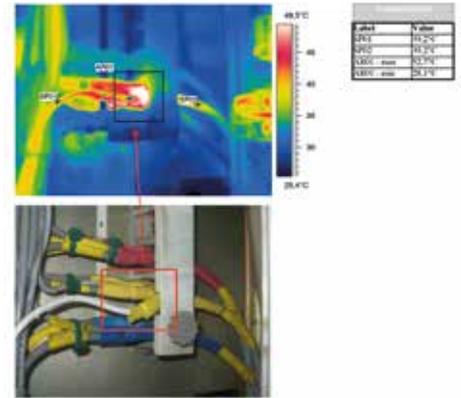
The FLIR reporting software delivers a perfectly documented and detailed report of our findings to the technical staff that will do the actual repairs.

"The reporting software that comes with the FLIR P640 is very easy to use and allows us to deliver a perfectly documented and detailed report of our findings to the technical staff that will do the actual repairs. We regularly receive the latest updates from the FLIR software so we can enjoy extra features."
