The building diagnostic tool preferred by professional home inspectors

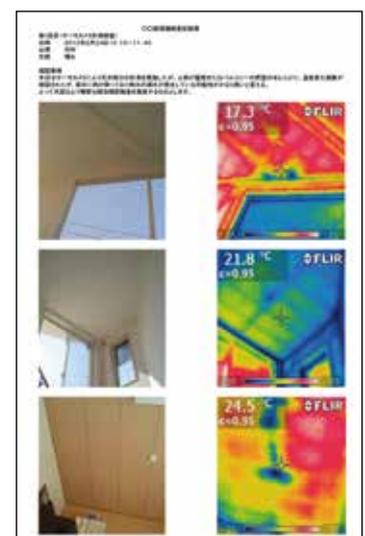
An example of diagnostic report of water leak inspection by Mr. Ichimura. Using infrared thermography helps to identify the exact location of leaks such as on the ceiling speedily so as to improve inspection efficiency.

“For water leaks, severe leaks can be visible as a stain on the building materials but normal moisture ingress is very difficult to identify and locate. Conventionally, moisture inspection was laborious and time-consuming. First, a house inspector would guess where a leak might occur based on the structure of the house. Then, a water leak would be simulated and the site of the suspected leak tested by touching it. The biggest problem with using the conventional method was that in order to judge the extent of the leak further damage had to be caused to the building. Using infrared thermography, however, it is possible to determine the exact location and degree of the leak without causing damage and allowing efficient inspections,” said Mr. Ichimura.

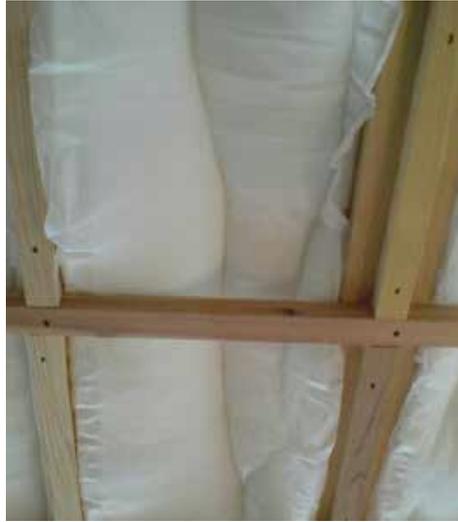
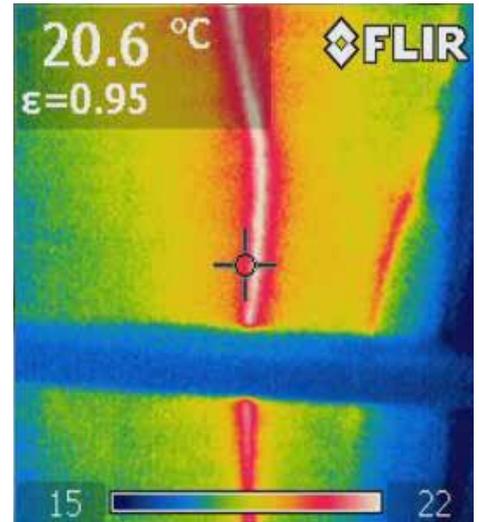
Example of shoddy construction: There are spaces between insulation materials, resulting in an unwanted air current.

the choice and installation of insulation is correct. During construction stages, you can check the presence of space between insulation materials and if required request remedial work, to prevent new homes being defectively built.

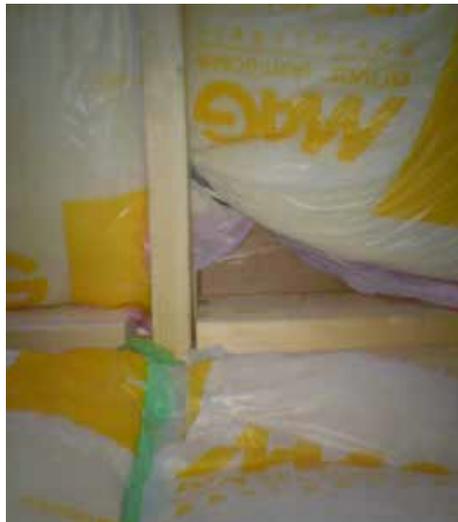
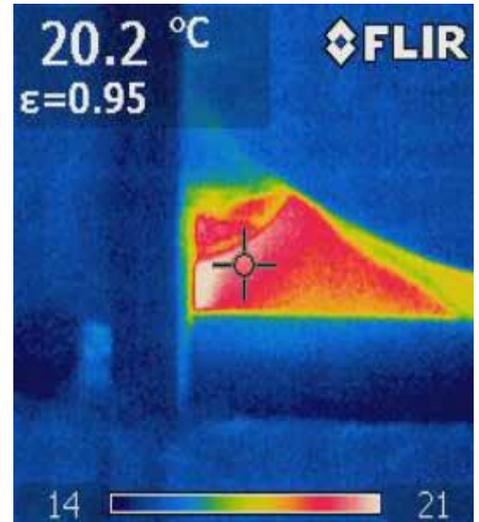
Example of shoddy construction: the insulation left overturned after electrical work
