Exterior wall inspections using high precision thermal cameras

1. Principles of infrared wall inspection

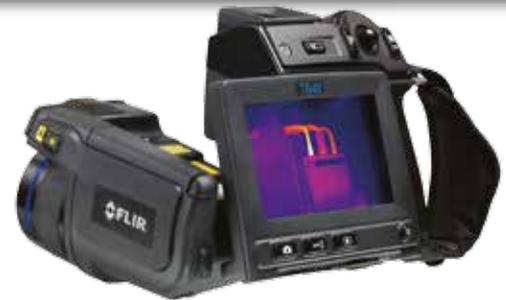
The FLIR T640 thermal camera combines excellent ergonomics with highest quality 640 x 480 pixel infrared resolution producing clear images rich in detail, making it ideal for building inspections which require many hours of hands-on labor.

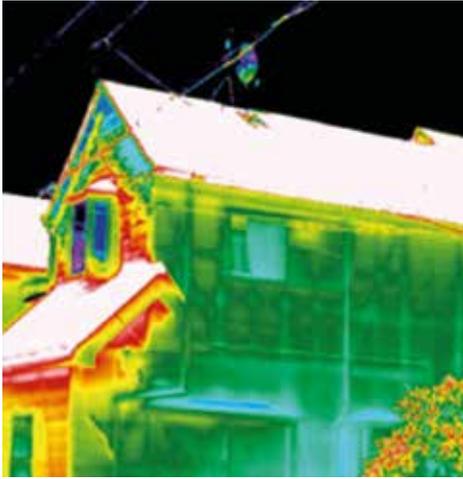
Figure 1 Thermal camera image

Infrared is electromagnetic radiation with a wavelength that is longer than visible red light, but shorter than radio waves. Infrared is invisible to the naked eye. Infrared thermal imagers (thermograph or thermal cameras) are devices that capture infrared wavelengths (heat) emitted from objects to enable the visualization of the heat distribution (Figure 1).

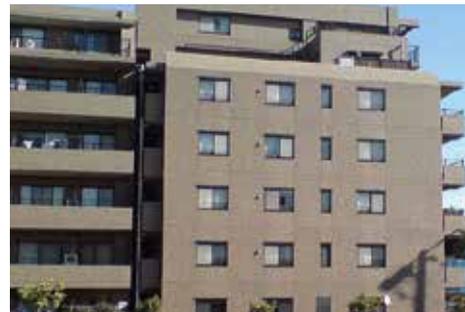
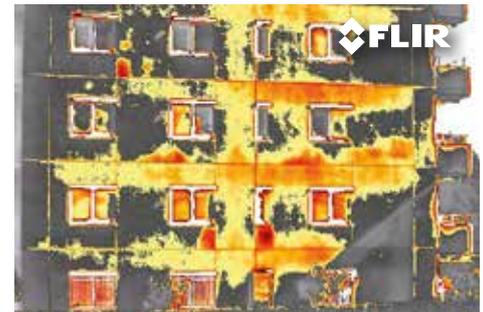
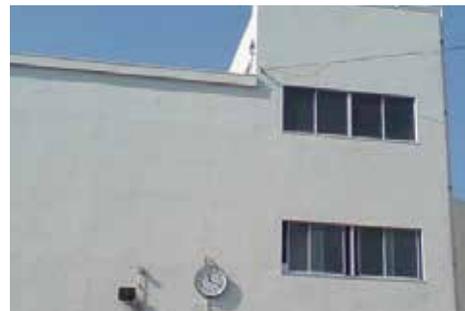
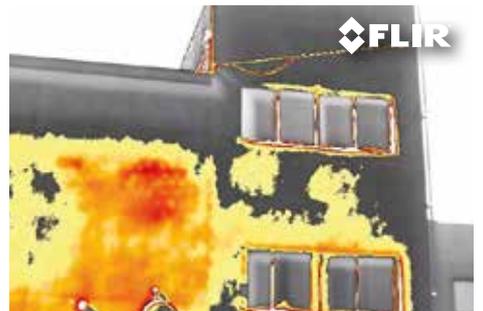
Figure 3 Examples of outer wall inspections using infrared thermal cameras

Visual image

Thermal image

Figures 3 and 4 show examples of inspections using infrared thermal cameras.

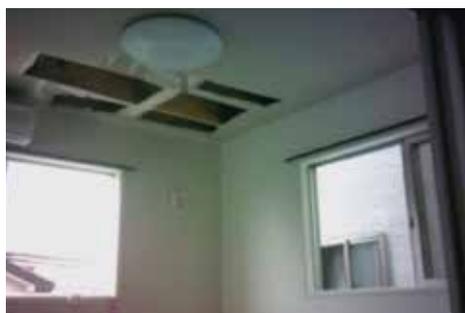
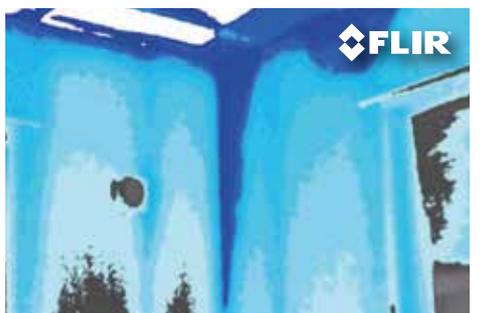
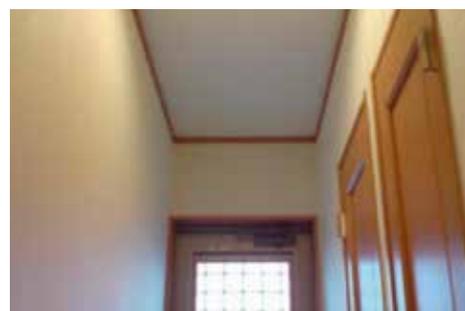
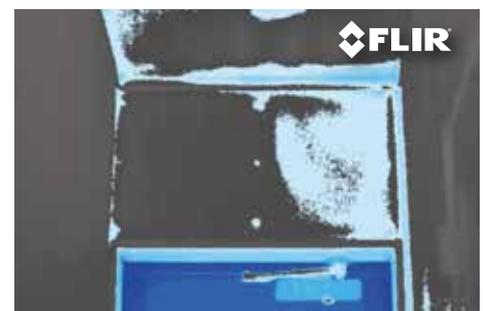
Figure 4 Examples of infrared inspection (water leakage inspection)

Visual image

Thermal image
